NASA Contractor Report 159261

VISUALIZATION OF IMPACT DAMAGE OF COMPOSITE PLATES BY MEANS OF THE MOIRÉ TECHNIQUE

W. G. Knauss, C. D. Babcock, and H. Chai

NASA Grant NSG-1483 April 1980

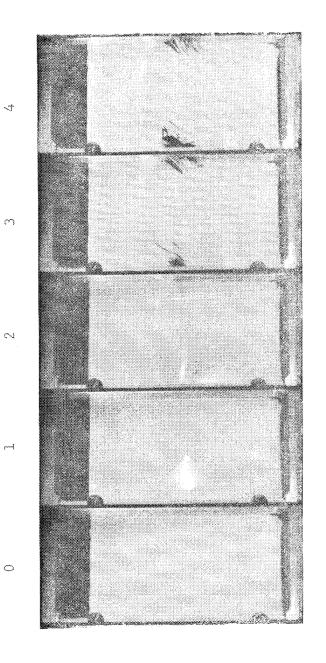
Fig. 7 Test Panel A-2, 9,000 frames/sec.

The first tests were conducted using reflected light photography. Test panel A-2 is shown in fig. 7. The time between frames is 110 μs . Frame one of this sequence shows what appears to be a bulge in the surface. Extensive damage in the region near the edge is evident in the next frames.

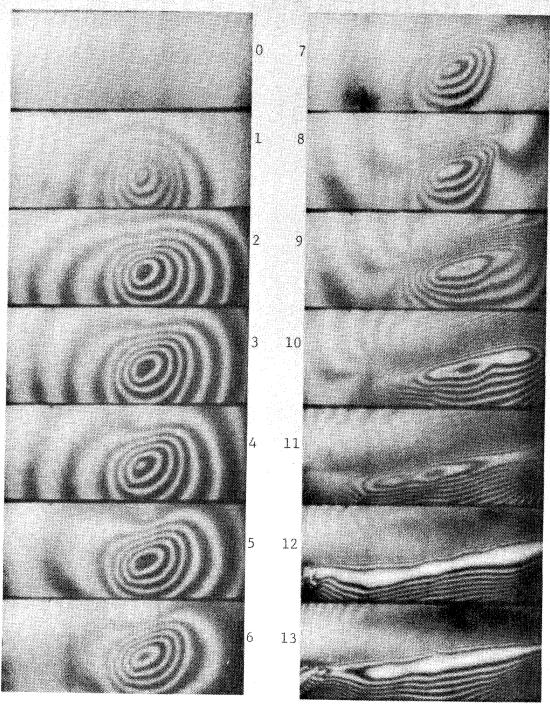
Fig. 8 Test Panel B-2, 16,500 frames/sec.

The results for panel B-2 are shown in fig. 8. The impact point is not centered in the picture. The field of

view is 86 x 29 mm and the time between frames is 61 μ s. The impact causes a peak displacement on the back surface of the order of 1 mm. This displacement changes very little for six frames ($\simeq 360~\mu$ s) indicating that it represents permanent deformation. Frame 8 shows a rapid growth which is interpreted to be bulging of the outer laminates of the panel. The growth appears to start at a slight angle to the horizontal. This pattern of growth was observed in some but not all subsequent tests. The most distinguishing feature of this sequence of photographs is the delay between the initial damage phase and the subsequent damage propagation phase. This feature will be discussed further in this report.

Another observation of interest has to do with the time at which the damage spreads after initial impact has occurred. In this connection it is well to remember that most of the experiments were conducted in the vicinity of projectile velocity of 60-70 m/sec. According to fig. 6, this falls into the steeper portion of the curve relating failure strain to projectile velocity. For most of the experiments it was quite clear that damage in the form of a displacement peak under the impact point occurred very rapidly but the damage did not spread immediately. For example, in fig. 11 it took something like 24 frames or the equivalent of 1.2 ms before the damage started to grow significantly. After it started to grow, the growth was relatively rapid. Again, by comparison fig. 8 shows that damage did not appear to grow for

approximately eight frames or the equivalent of 0.5 ms and then grew very rapidly. Finally, from fig. 9 it is evident that damage grew almost from the very beginning of impact. While it may on cursory examination appear that there may be two modes under which damage spreads it is believed that this is related to the strain level. Panels that are closer to the threshold curve tend to have an early propagation of the damage area while those further away exhibit a slight delay of propagation.

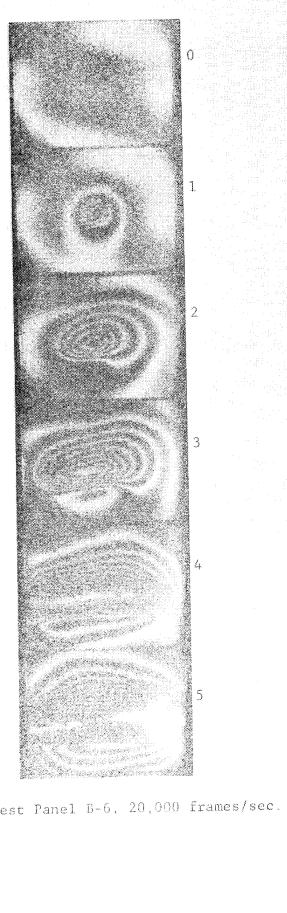
Fig. 9 Test Panel B-6, 20,000 frames/sec.

The results for test panels B-6 and B-9 are shown in figs. 9 and 10. These photographs show larger fields of view than that for B-2. The sequence of events is much the same as before but the time delay is different. B-6 (fig. 9) shows a delay of less than 50 μ s (the time between frames) while B-9 exhibits a slow growth for about 200 μ s, followed by a large deformation of the back surface.

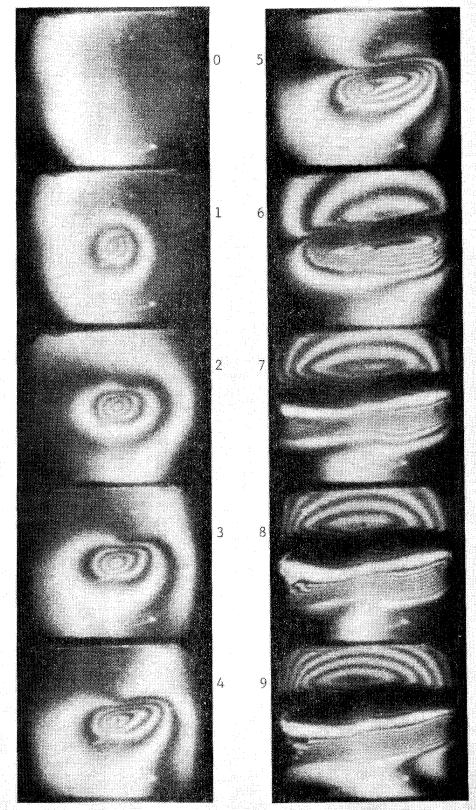
Fig. 10 Test Panel B-9, 19,900 frames/sec.

approached. In viewing figs. 8 through 10, it is clear that the initial deformation resulting from impact damage is nearly circular in shape, but invariably when spreading occurs, it does so in a transverse direction, that is, horizontally. Bearing in mind that in all these figures the load is applied along an axis from top to bottom of the figure, it shows clearly that the delamination occurs at right angles to the compressive load. It is believed that the reason for this phenomenon is based on fracture mechanics and energetic The damage area is somewhat like a section considerations. of reduced modulus. Local buckling of the delaminated region shifts the stress distribution in a manner similar to that resulting from a hole. The high stress regions are on a line normal to the load axis. Some spread parallel to the load axis is evident but the predominant propagation is normal to the load axis.

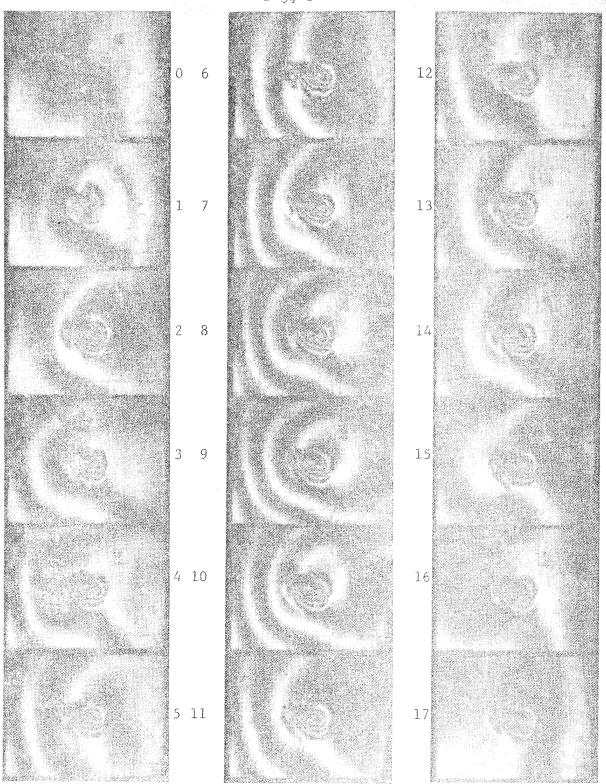
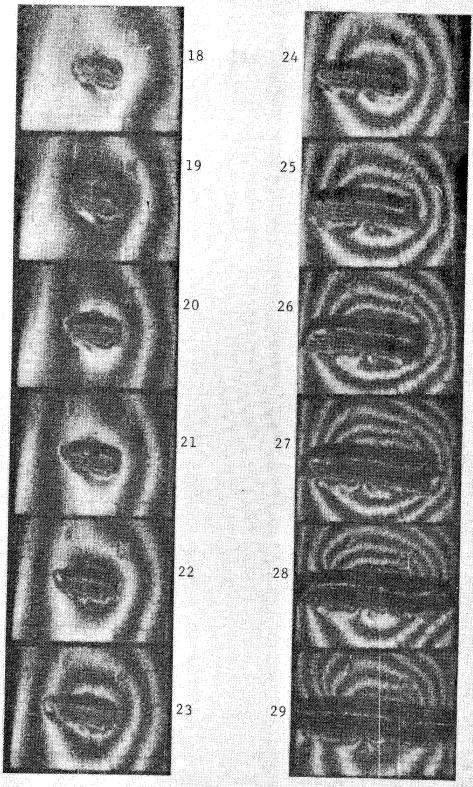
Fig. 11 Test Panel C-2, 19,000 frames/sec.

Figure 11 shows the moiré photographs for test panel C-2. This panel is larger than those previously discussed (254 x 152 mm vs. 203 x 101 mm). The fringe quality is not particularly good for this series of photographs but the sequence of events can be detected. The rapid growth of the damage area does not begin until frame 24 (1200 μ s). Prior to this the damage area is almost stationary with a slow

growth beginning in frame 17. Superimposed on this "permanent" deformation is what appears to be a plate vibration motion.

The half period (ending in frame 16) corresponds to a frequency of about 600 Hz.

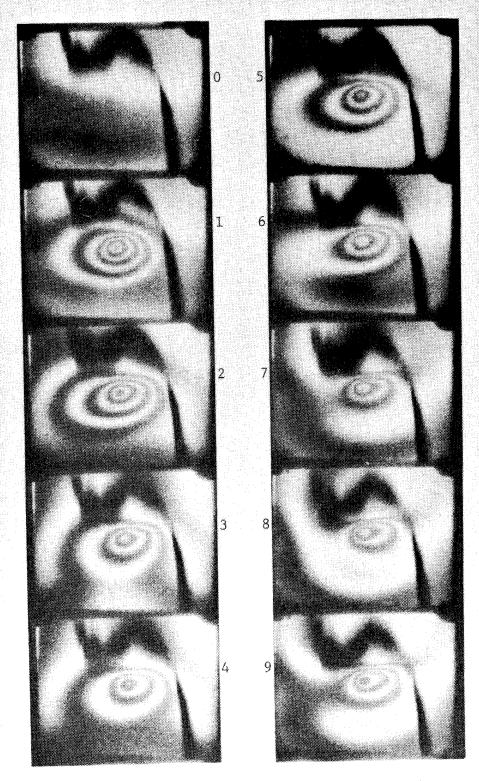
Fig. 13 Test Panel B-4, 21,000 frames/sec.

The photographs for test panel B-4 are shown in fig. 13. The irregular dark pattern in this series of photographs is due to an optical interference. This panel was impacted at the same velocity as B-5 but was preloaded to a strain of 3180 $\mu\text{m/m}$. Catastrophic failure did not occur until approximately one minute after impact. The back surface permanent deformation was about 0.8 mm out of a total deformation of about 1.3 mm. Comparing this result to that of B-5 indicates some coupling of the in-plane load and the impact.

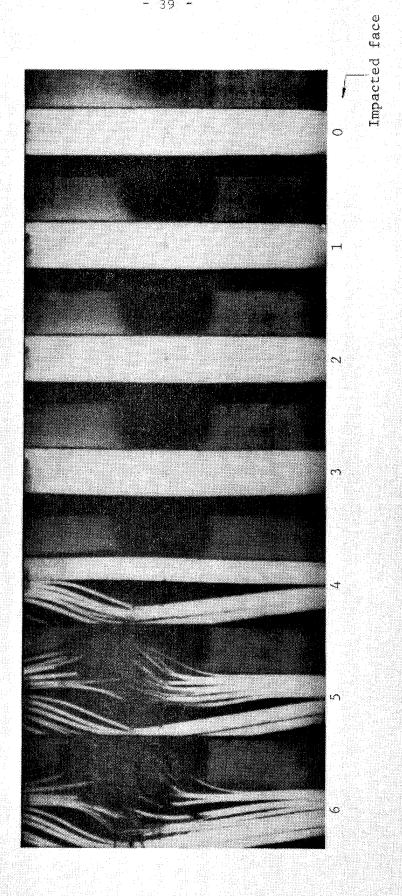
Several test panels were impacted and the side of the specimen photographed. These results are shown in fig. 14 for test panel A-3. The test panel is unsupported over the field of view shown in the film sequence. Frame 0 shows the projectile advancing towards the specimen. Impact was estimated to occur 45 μs after frame 0. Frame 2 shows a central crack extending the whole width of the photograph (85 μs after impact). The plate edge moves approximately 0.25 mm in frame 3. Additional cracks (delaminations) occur

in subsequent frames accompanied by front and rear surface buckling and complete rupture of the panel. This sequence of photographs (highlighted by the early appearance of an edge crack) led to similar tests on two other panels (AB-1, AB-3).

(The portion of the test panel shown is free from support.) Fig. 14 Test Panel A-3, 15,500 frames/sec.

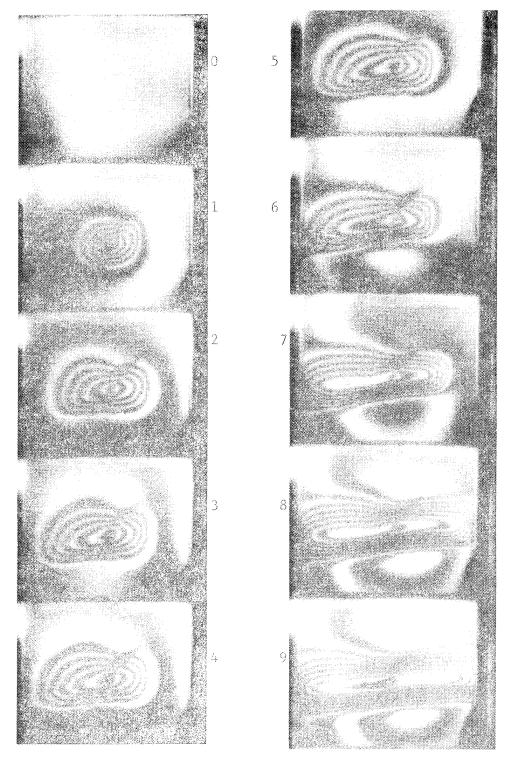
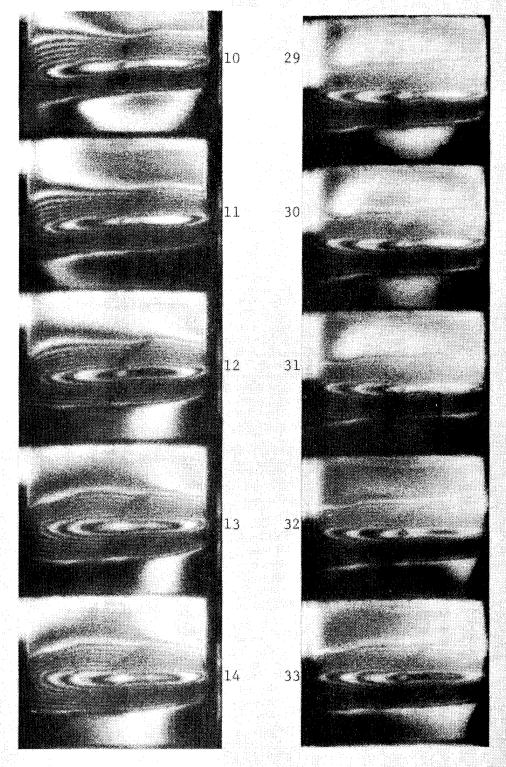
Fig. 15a Test Panel AB-1, 19,800 frames/sec.

Test specimen AB-1 was supported with the small specimen support. A window along the side of the support was cut so that a side view photograph could be made. The panel was supported along its entire length. The moiré pattern obtained for test AB-1 is shown in fig. 15a and the side view is shown in fig. 15b (corresponding to the left side of fig. 15a). Based on the common timing pulse, it was found that frame 0' (side view) is 14 µs later than frame 0. The characteristic deformation propagated along the specimen width and reached the left side boundary in frame 6. Note that its tip is pointed down about 7 mm. Frame 6' (14 µs later than 6) shows an initial appearance of a central crack. In frame 7' the crack has extended through the full length of the pictures. This was accompanied by the appearance of a larger crack (5 mm long) pointed downward from the impact level (central

spot). The short crack appearance is attributed to the deformation recorded in frame 6. Frames 29' to 31' show the complete failure of the test specimen.

photograph of the plate (fig. 15b) that the first crack appears at the edge at roughly the time at which in the other picture (fig. 15a) the moiré pattern has reached the left boundary of the plate. As a result of this experiment the front of the internal propagating delamination has been associated with the first or lowest order fringe in the moiré pattern. This assignment of the propagation front is a bit arbitrary; however, for the present purposes of an engineering interpretation of the phenomenon occurring in the damage progression it seemed quite sufficient. Further examination of the propagating damage will use this definition for the extent of the damage region.

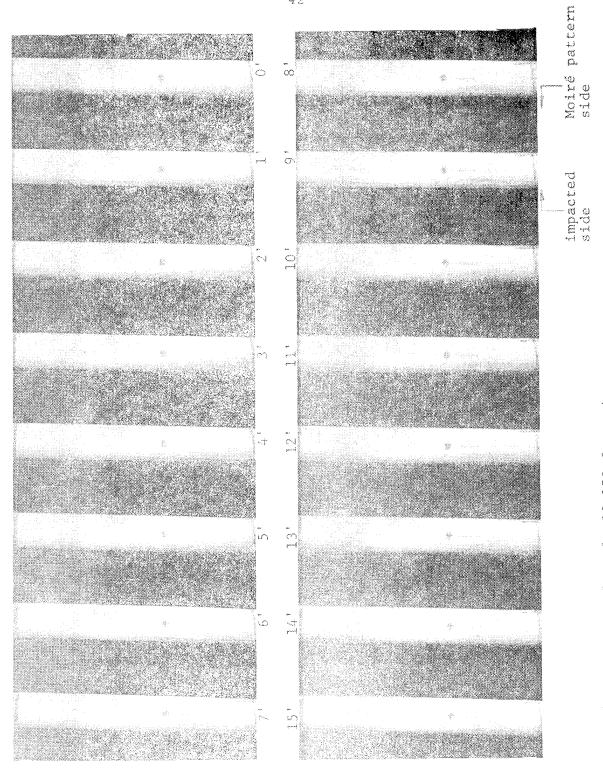
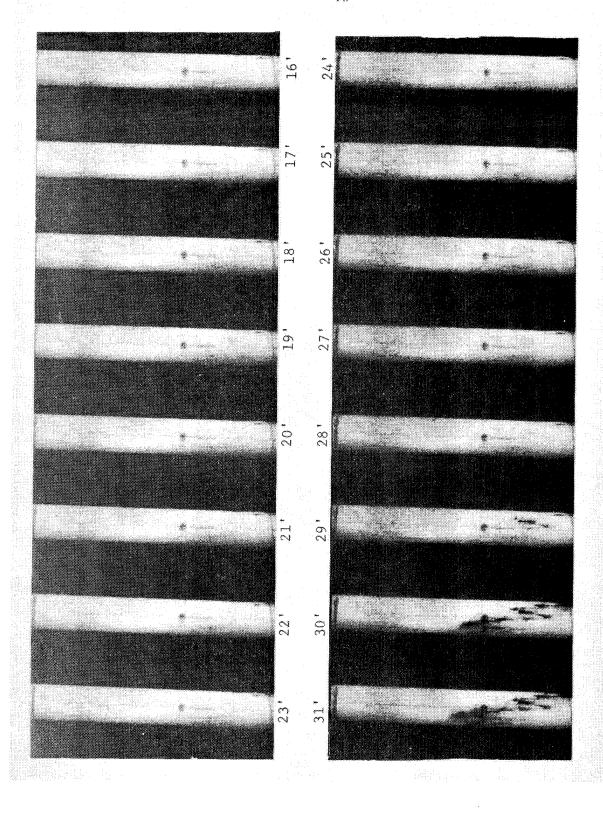
ig. 15b Test Panel AB-1, 18,150 frames/sec.

Having tentatively established so far when and how rapidly the delamination propagates it is appropriate to comment on the final stages of the compression failure. In fig. 15b, the edge view of a specimen is recorded. The point where a single central crack has appeared and further damage results in a gross fashion occurs in the frames after and including frame 29'. The time corresponding to frame 30' is about 1.5 ms after impact. There are two reasons why this final failure phenomenon may occur at this time. First, since the natural frequency of vibration is on the order of 2000 Hz, the phenomenon might possibly be related

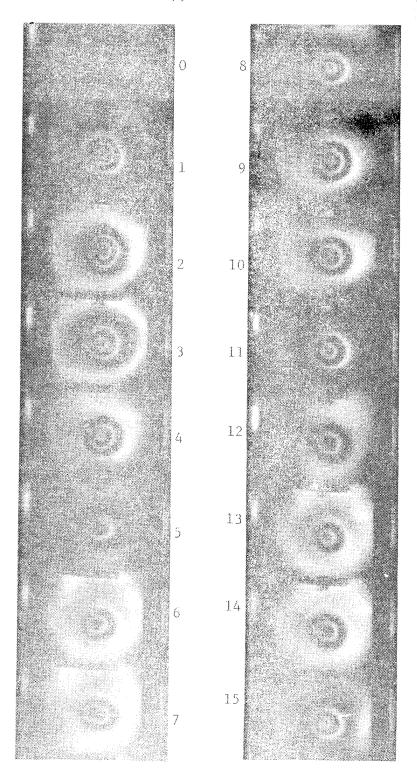
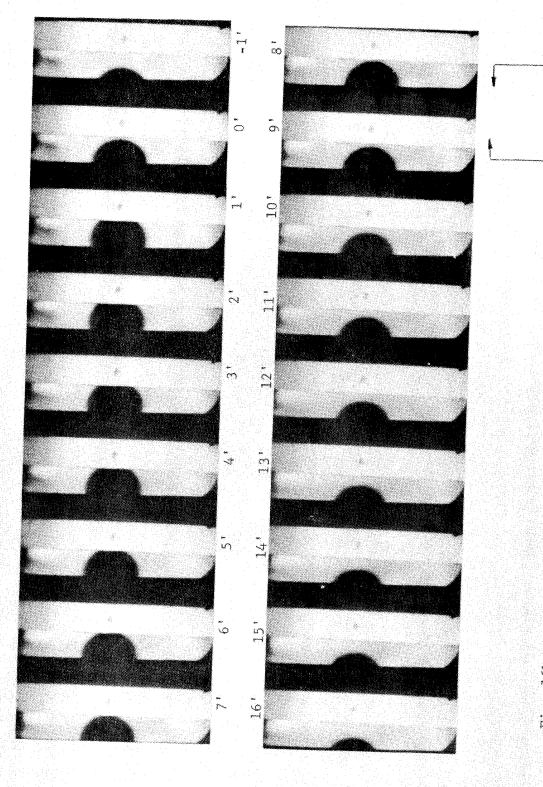
Fig. 16a Test Panel AB-3, 18,400 frames/sec

Test panel AB-3 was trimmed to its size from a large specimen type of lot number 2. The photographic results are given in figs. 16a and 16b. Frame 0' was calculated to be 30 μs before impact and 28 μs after frame 0. This test panel did not fail catastrophically and there is no evidence of any edge cracks. A permanent surface displacement of the order of 0.6 mm is visible in fig. 16a. The impact duration and rebound velocity were found to be 70 μs and 7 m/sec from fig. 16b.

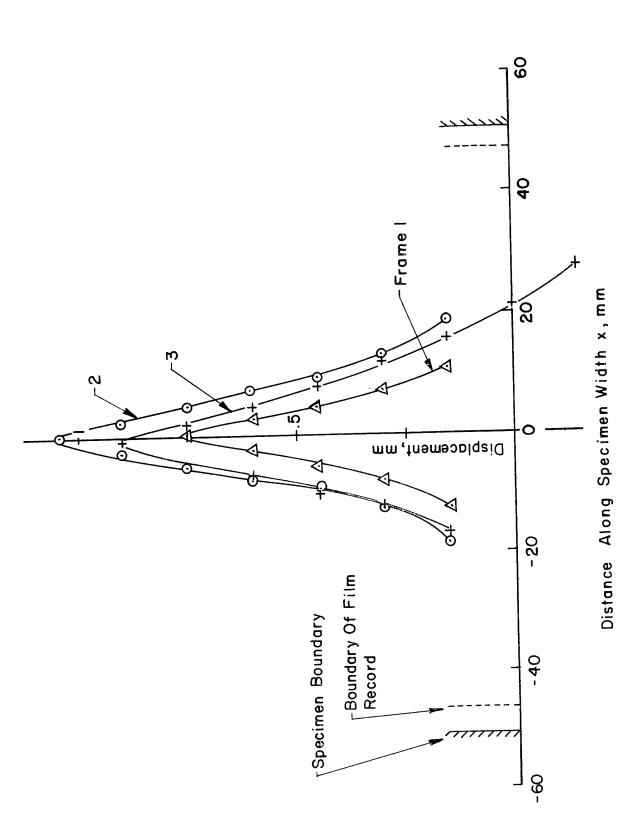
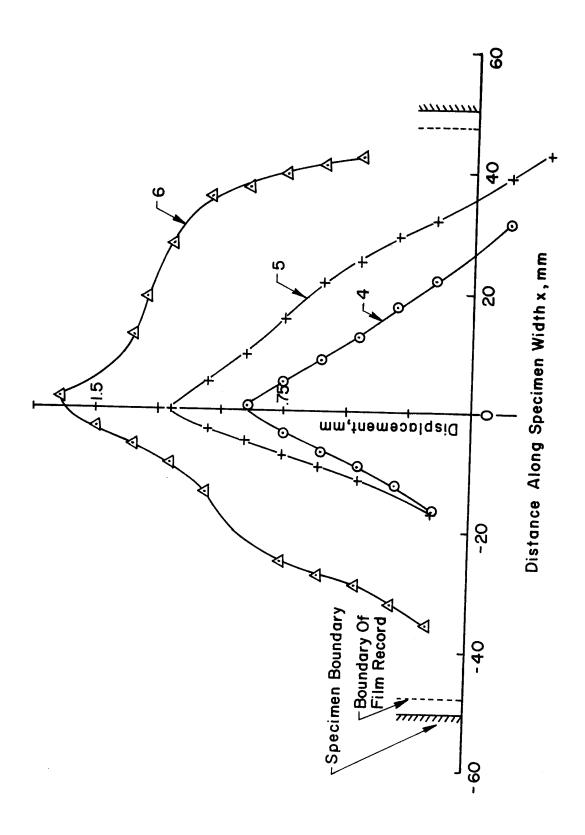
The contours of surface displacements can be converted to displacements and displayed as displacement versus distance plots. This type of result is shown in fig. 17 for test panel B-9. The time between frames is approximately 50 μs . The rapid spreading of the damage is evident after frame 4. The velocity of this spreading will be discussed in the next section.

FIG. 17 TEST PANEL B-9 OUT OF PLANE DISPLACEMENT ALONG SPECIMEN WIDTH (time interval between frames – $50.25\,\mu s$)

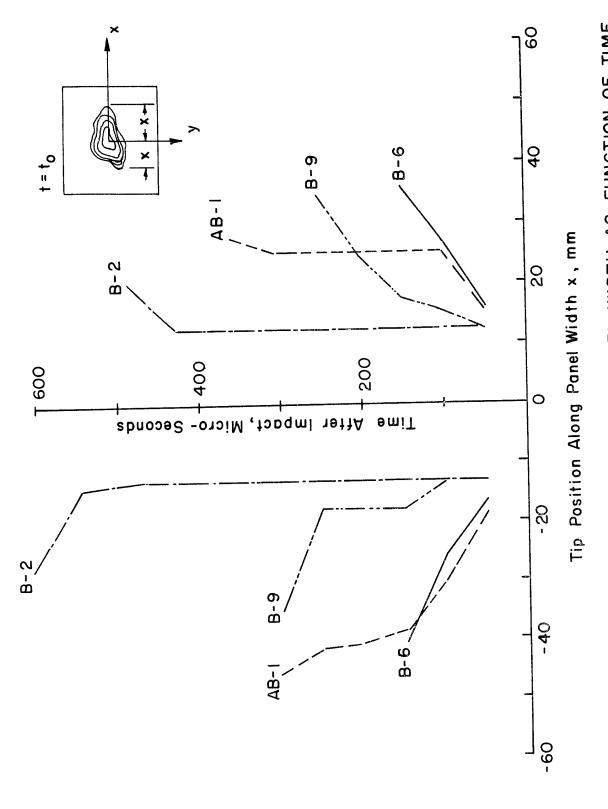
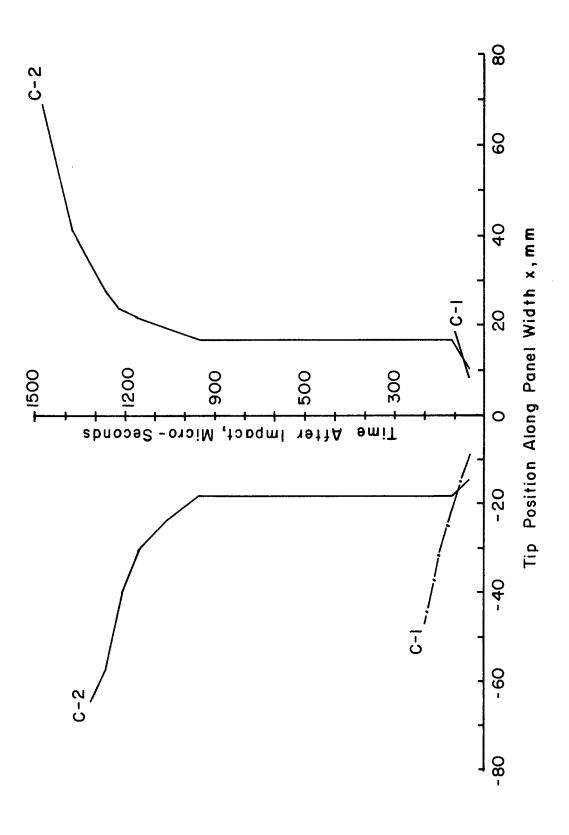
Having commented on the time history of the delamination spreading, it is of interest to indicate an estimate of the rate at which this spreading occurs. This information can be directly found using fig. 18. From this figure it was deduced that the maximum velocity falls in the range of 1.4×10^3 m/sec to 3.3×10^3 m/sec. The average value of this maximum was 1.9×10^3 m/sec (7500 in/sec). While this velocity is substantial it is slow compared to a typical in-plane wave velocity for this material.

TIP POSITION ALONG PANEL WIDTH AS FUNCTION OF TIME FIG. 18 DELAMINATION
